Wild-Frey Farm Historic Resources Survey Report

7970 Liberty Road
Scio Township
Washtenaw County, Michigan

Washtenaw County Office of Community & Economic Development
Final Report
December 1, 2022

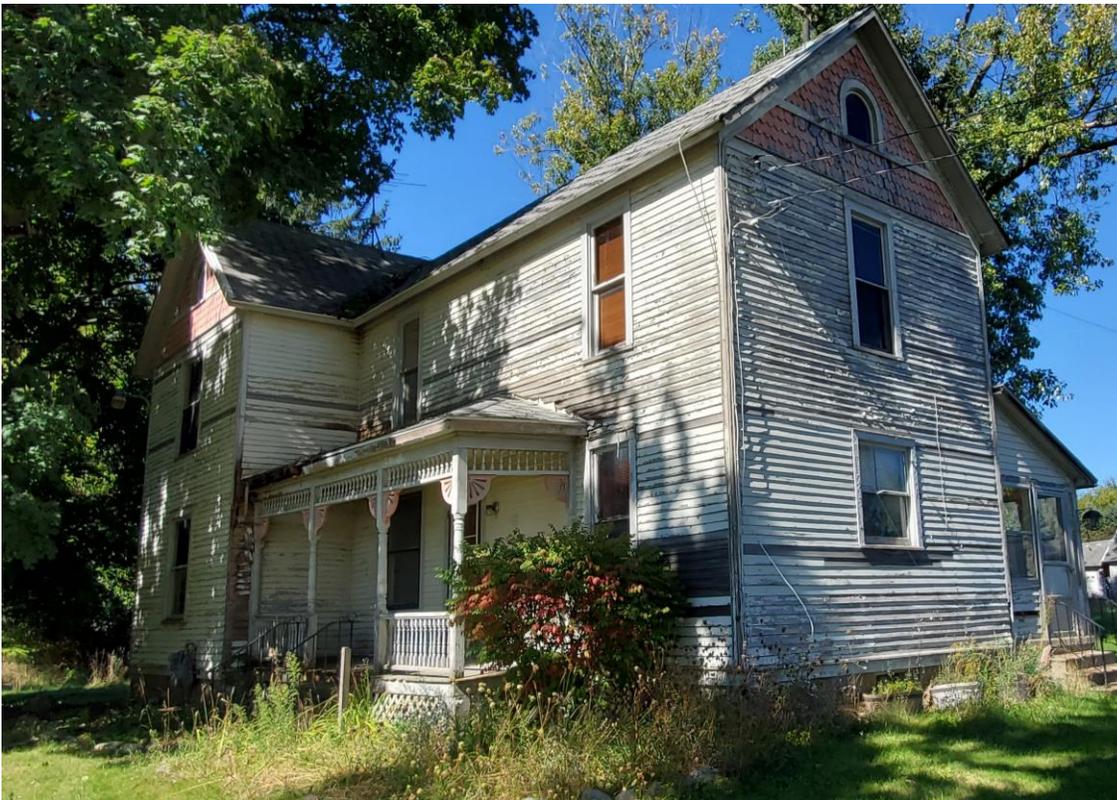
Farmhouse

Facing northwest from the dooryard/front yard.

This two-story gabled-ell dwelling is composed of a fieldstone foundation, horizontal wooden siding, double-hung sash windows, and an asphalt shingle roof. Decorative scalloped shingles fill the fields of the gables. The south-facing and east-facing gables are punctuated with a single-pane rounded arched window.

This house's primary elevation faces south, with a formal entry in the center of the ell portion of the house, framed by a one-story, hipped roof porch. The front porch is ornamented with turned railings and cut out brackets in the late Queen Anne style. All windows are intact, with wooden frames. Except for the larger parlor window on the south elevation, nearly every window is an elongated, double-hung sash. The first story window on the east elevation, which is the kitchen window on the long portion of the ell, appears to have been replaced with a slightly wider and more squat double hung window with a three-light upper sash.

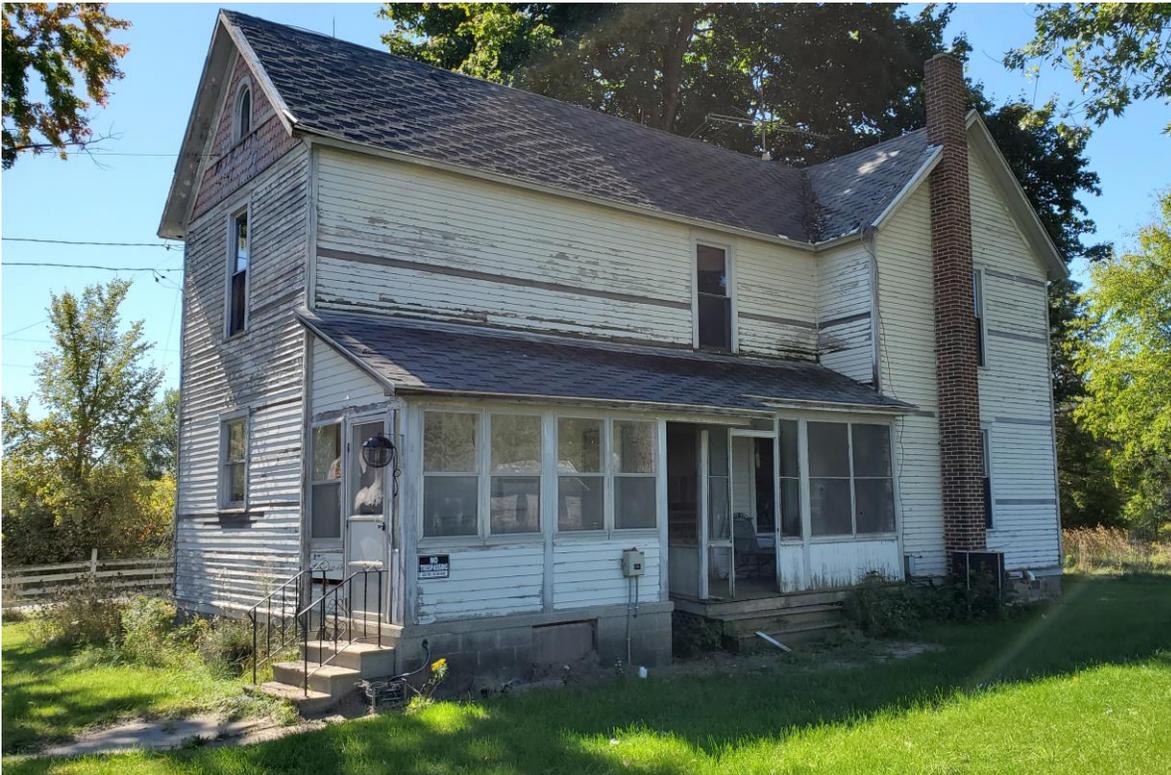
Farmhouse, continued:

Facing southwest from the rear door yard/back yard.

The rear of the house has an enclosed, one-story shed-roof porch running the length of the ell, with two separate entries split by a set of steps leading to an outside door to the basement. The east end of the porch has an east-facing aluminum door, the upper half of which is screened. This end of the porch is lined with squat double-hung sash windows of the same approximate dimensions of the kitchen window. The west end of the porch has a door-shaped opening mirroring the entry to the house, and the remainder of the porch is lined with screened window openings in the same cadence as the eastern half of the porch. The north-south gabled portion of the house has a single window centered on the first and second floors and a slender brick masonry vent stack positioned asymmetrically on the eastern half of the gable peak.

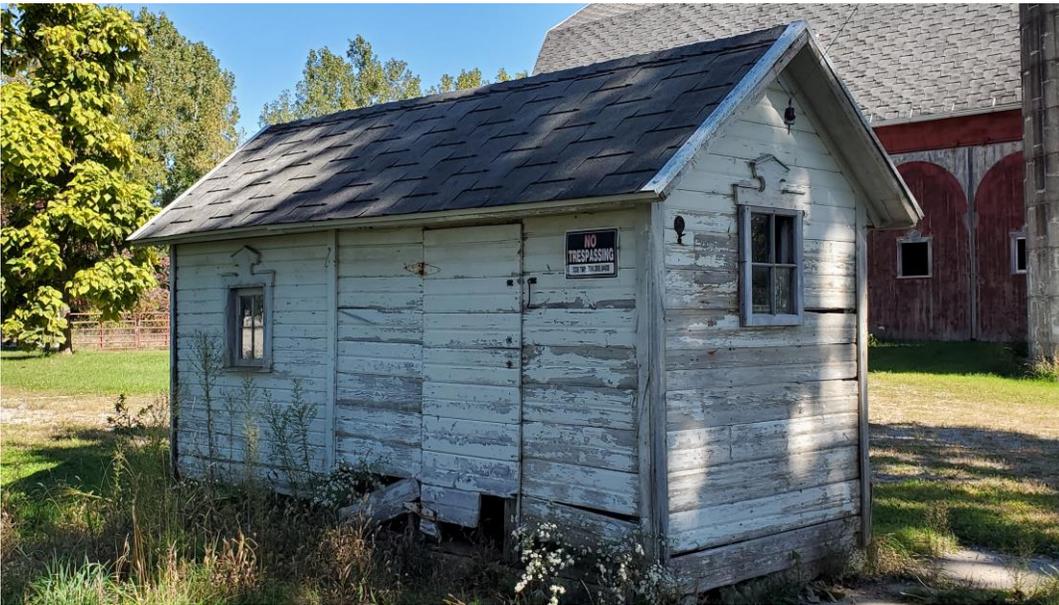
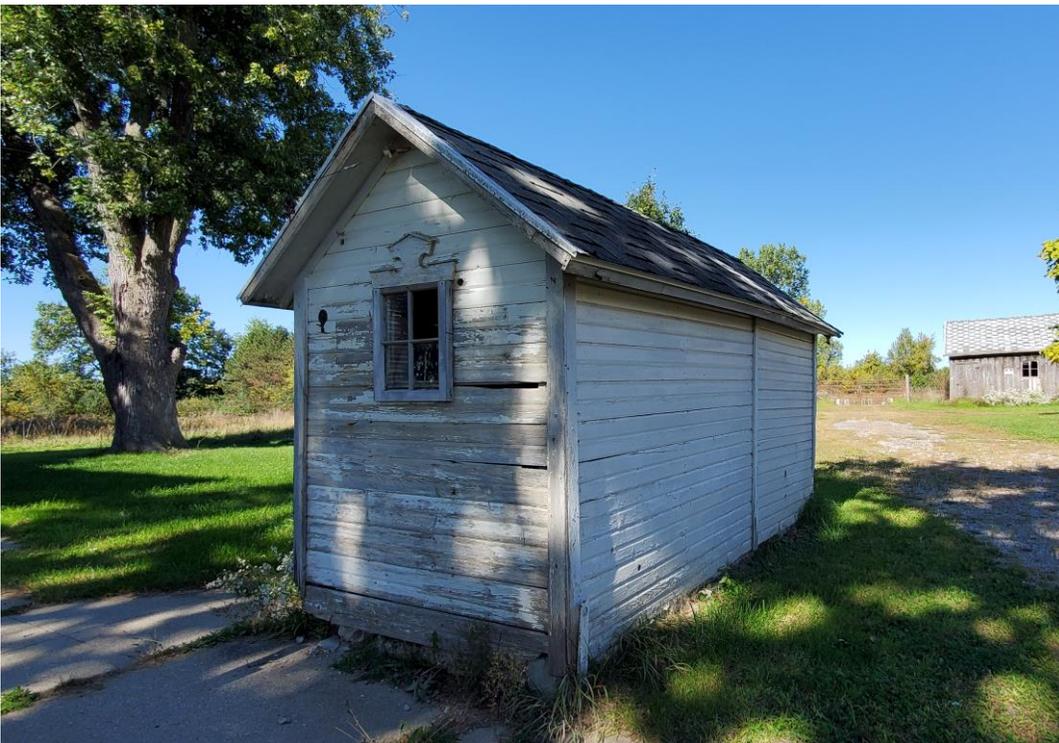
Toolshed

Facing northeast from the east side of the house; second view facing northwest.

This small, side-gabled shed has a poured concrete foundation and is clad in horizontal wooden siding. It has an asphalt-shingled gable roof. This shed has a vertical trim board covering a seam on both the east and west elevations. It appears to have been built in two parts or cobbled together from repurposed outbuilding parts, a fairly normal practice. It has a sliding door on the west elevation and the north elevation. An ornamental window hood, made of scroll-worked lumber, graces the top of square four-paned windows on the south and west elevations.

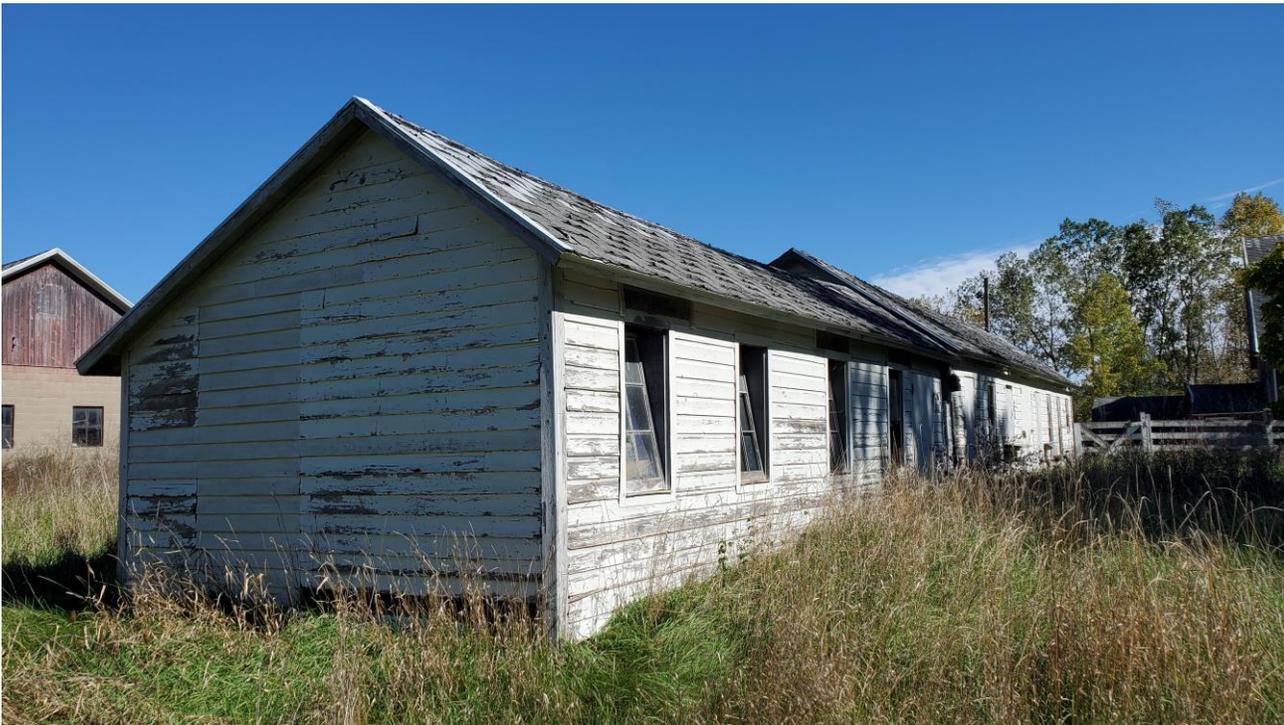
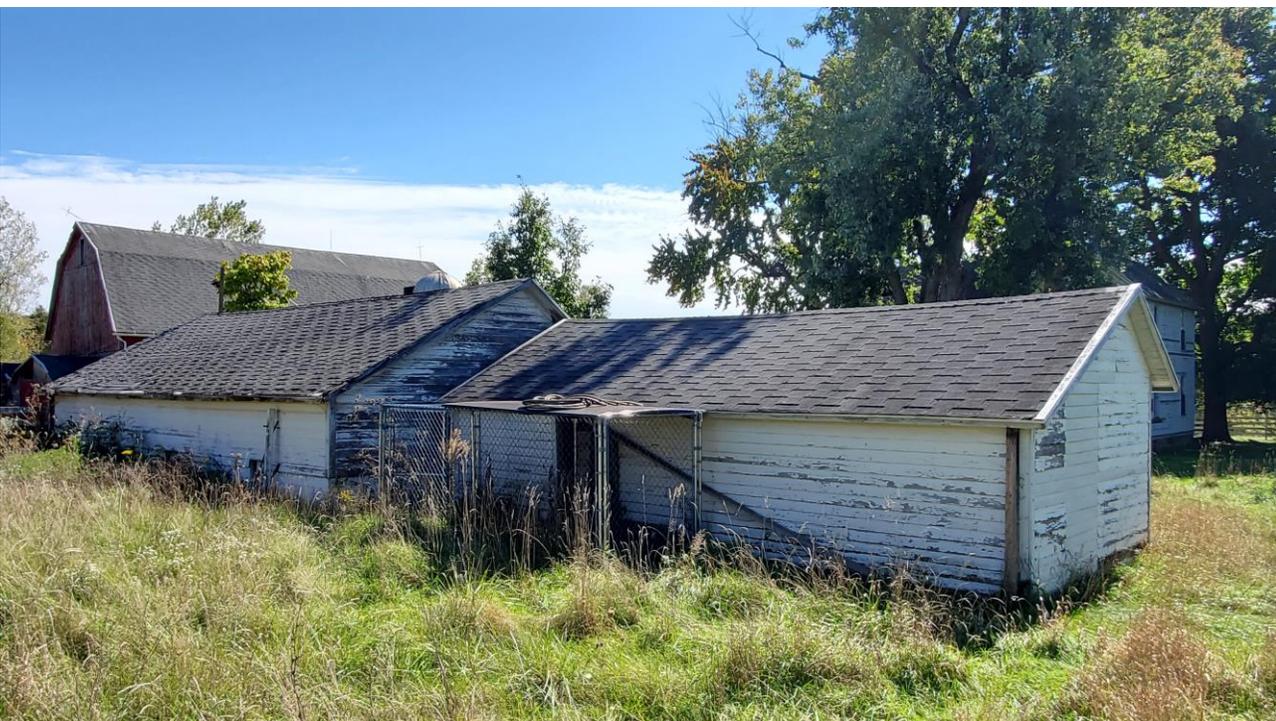
Chicken Coop

Facing east-northeast from the door yard/back yard; second view facing southeast.

This side-gabled poultry house faces south and has a small pedestrian door on that elevation. This structure has a concrete block foundation and is clad in horizontal wooden siding with an asphalt shingle roof. It maximizes the southern exposure with four eight-paned wooden windows, which tilt inward to promote air circulation. Its north elevation has a chain-link fence enclosure attached to an outside door, serving as a chicken run. This chicken coop is closely positioned next to and in line with the garage but is a separate structure.

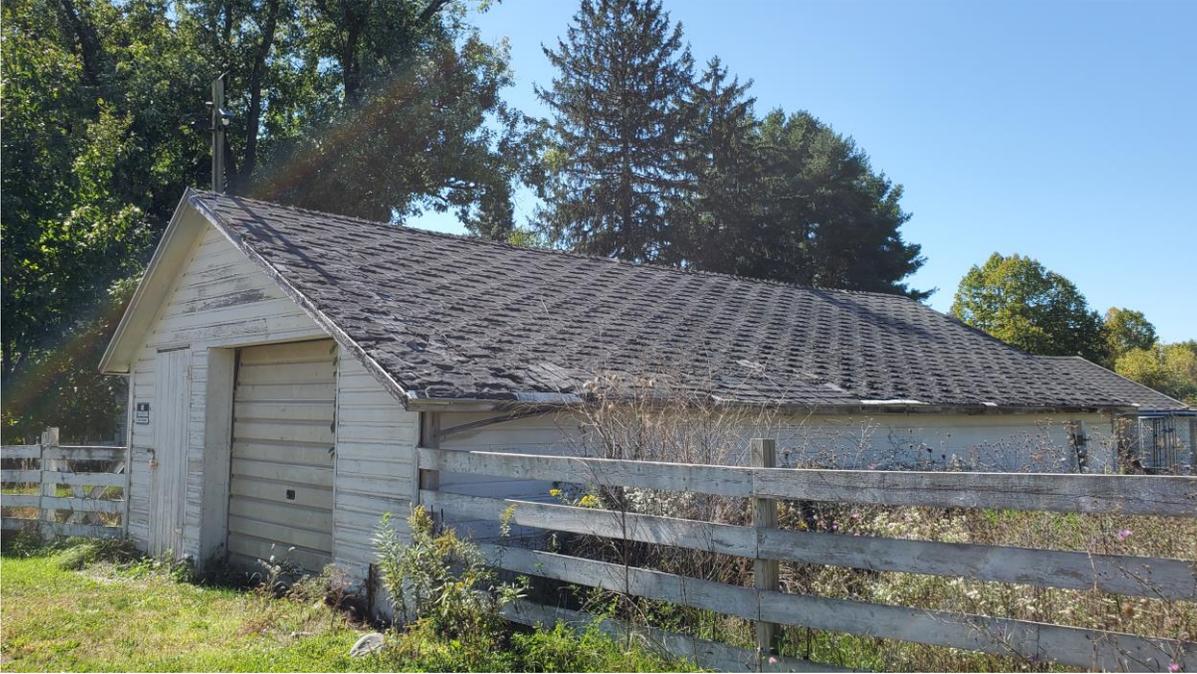
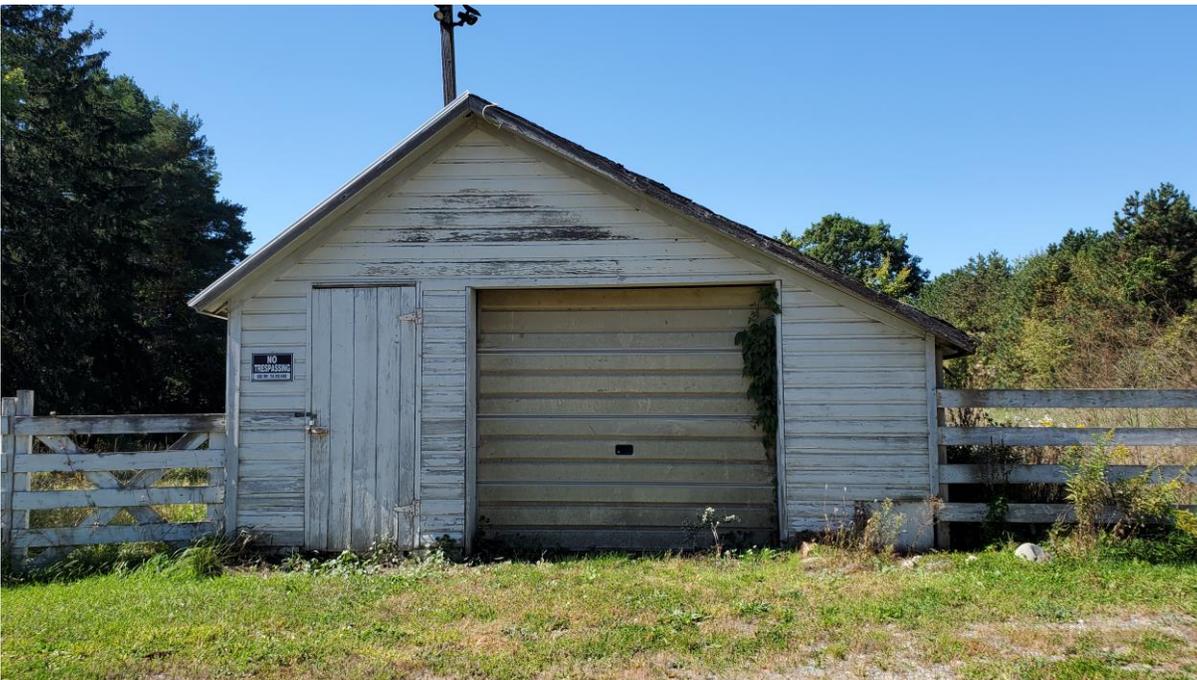
Garage

Facing southwest from the farm lane; second view facing west.

This asymmetrical gable-fronted garage is aligned with the Chicken Coop. It is similarly constructed, with a concrete block foundation, horizontal wood siding, asphalt shingle roof, and a small pedestrian door on the primary elevation composed of vertical wood panels. The single-bay garage door on the east elevation is made of translucent fiberglass.

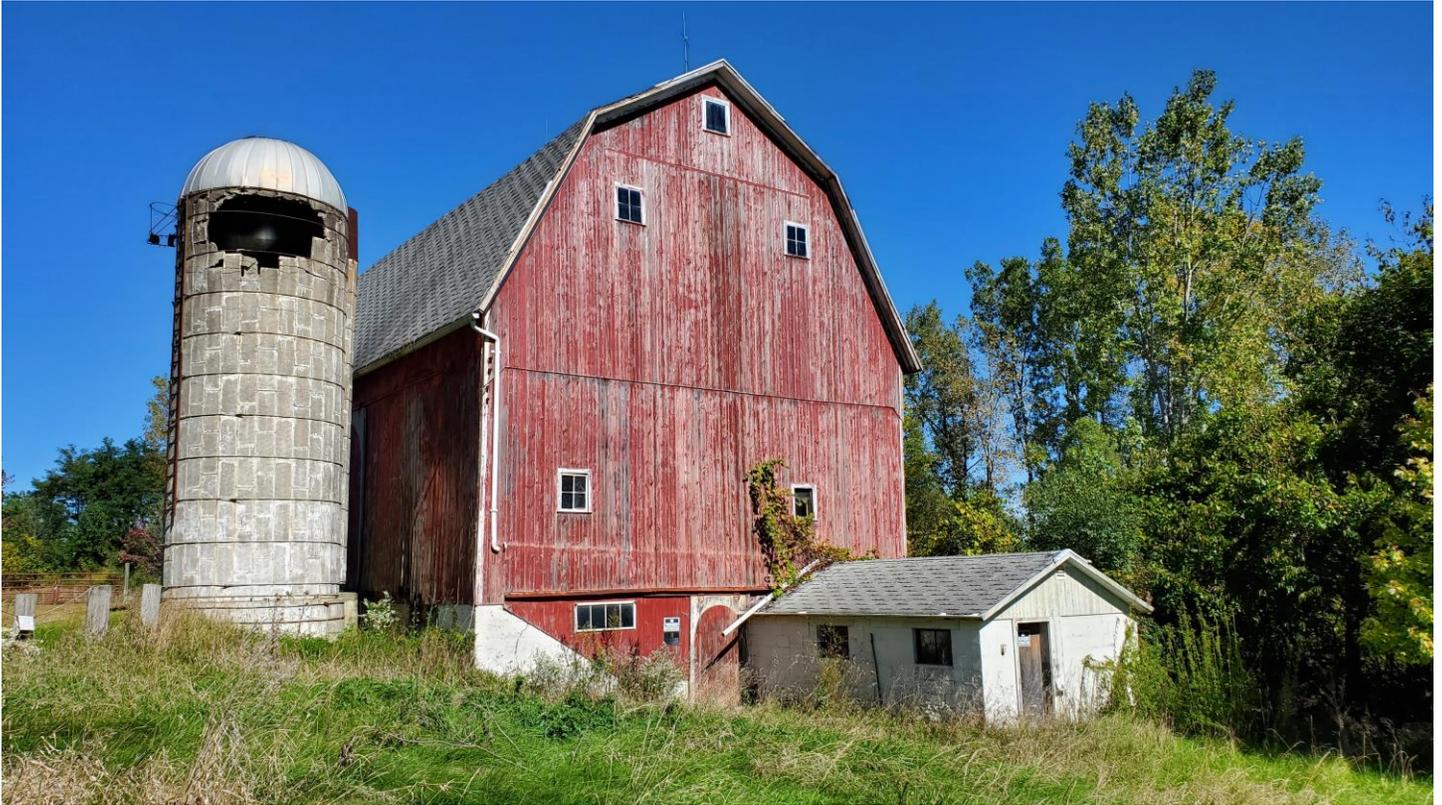
Barn Complex

Overview of the Barn Complex, facing northeast from the barn yard.

The barn complex is composed of several connected parts, all contributing to one continuous structure.

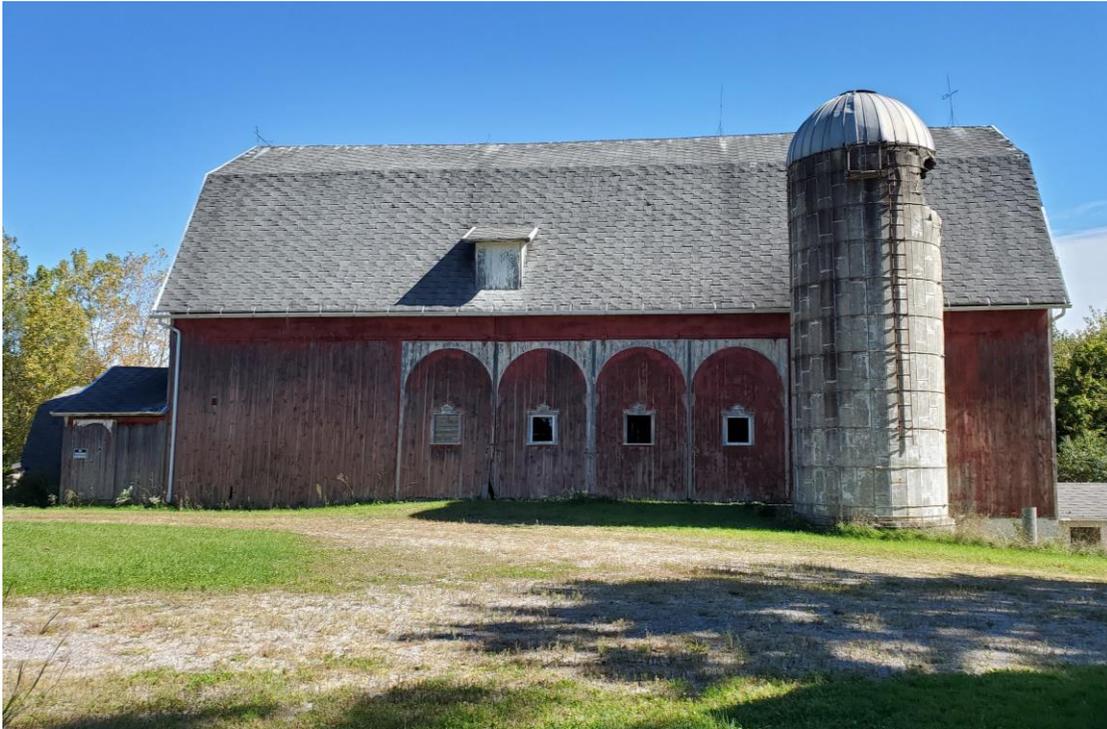
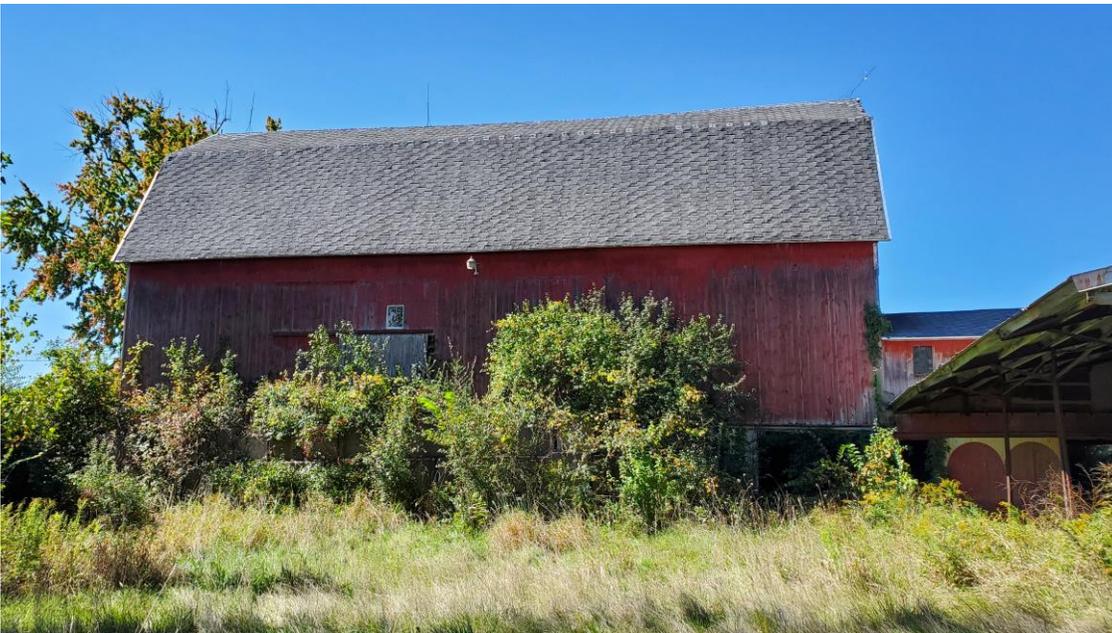
Core Barn Structure

Facing east from the barn yard; facing west from the east side.

This gambrel-roofed barn has a concrete block foundation and is sheathed in vertical wood siding. Its roof is covered with interlocking asphalt shingles. The west elevation includes a small shed-roofed dormer protruding from the hayloft. The primary elevation faces west, with four sliding doors outlined in white painted arches and punctuated with square window openings, which likely previously contained four square panes. The terrain slopes sharply downward from the west to the east side of the structure, opening the basement level to direct entry from the east via the Loafing Shed.

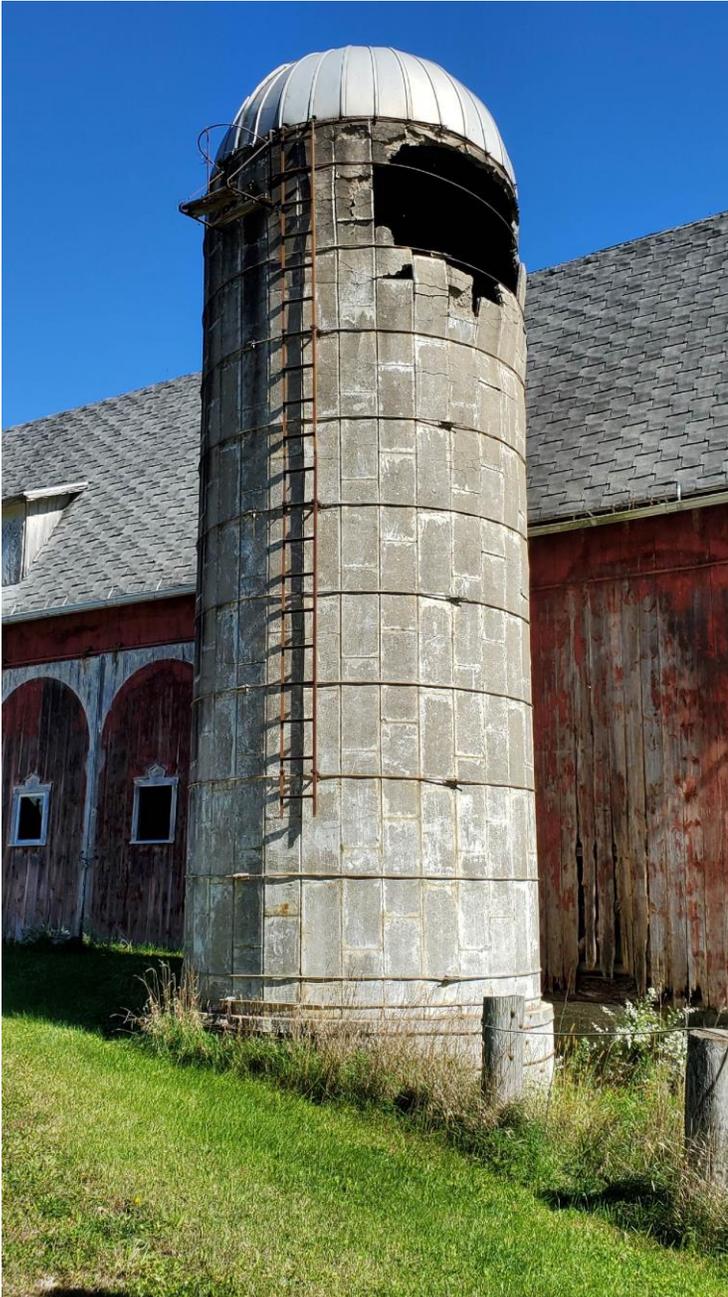
Silo

Facing northeast from the barn yard.

The silo has a heavily aggregated poured concrete foundation. It is constructed of rectangular concrete staves arranged vertically, banded in steel rebar, and topped with a standing seam aluminum cap. It has a steel rebar ladder attached to the structure on its southwest side. The silo has sustained damage and is no longer fully enclosed, with a gaping hole on the upper portion of the south elevation.

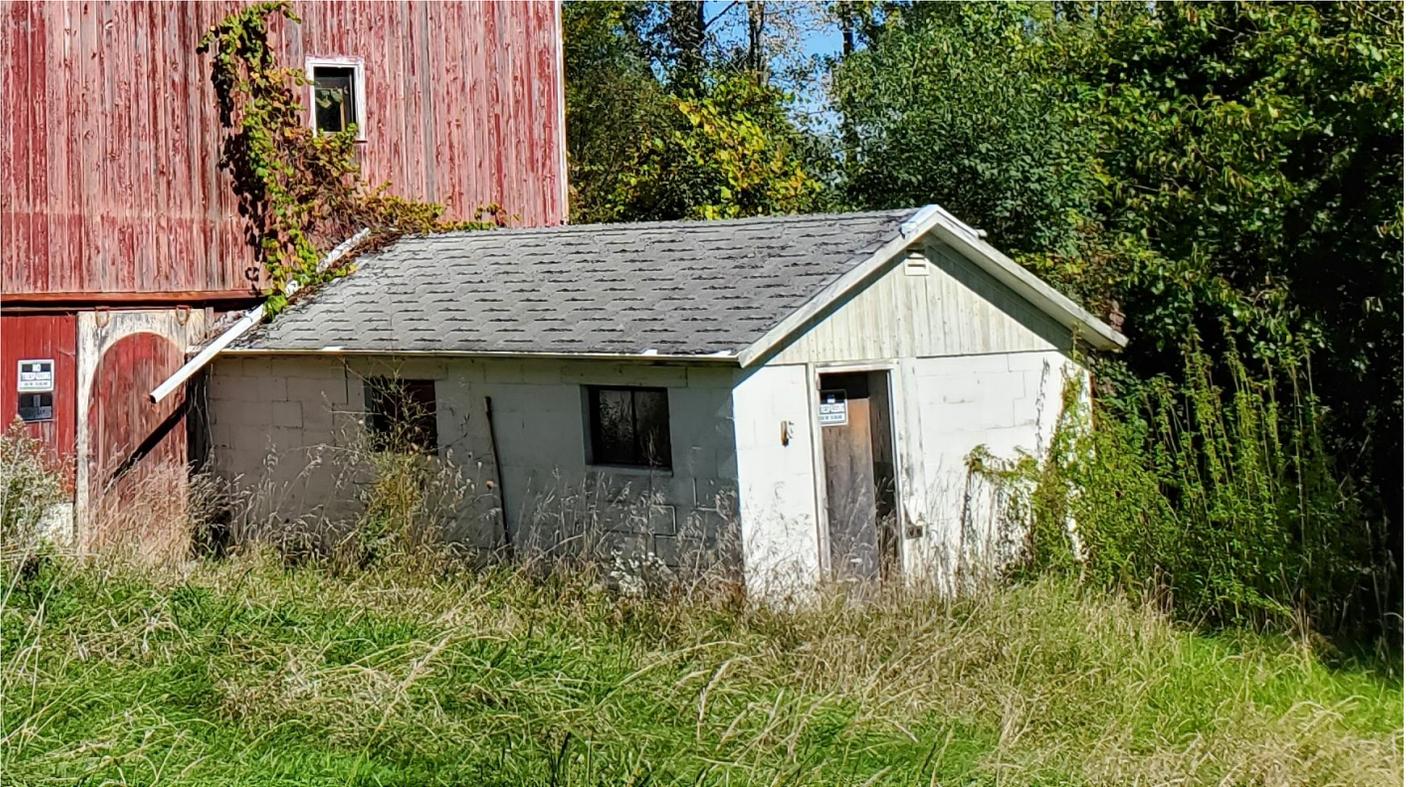
Milk House

Facing northeast from the barn yard.

This gable-fronted small appendage to the south elevation of the barn is constructed of concrete block. It has a concrete block foundation, concrete block walls, and vertical wood siding in its gable. There is a pedestrian entry on south elevation and direct access to the main barn from the north end of the structure. Two sets of vertically divided steel casement windows give light to the east and west elevations.

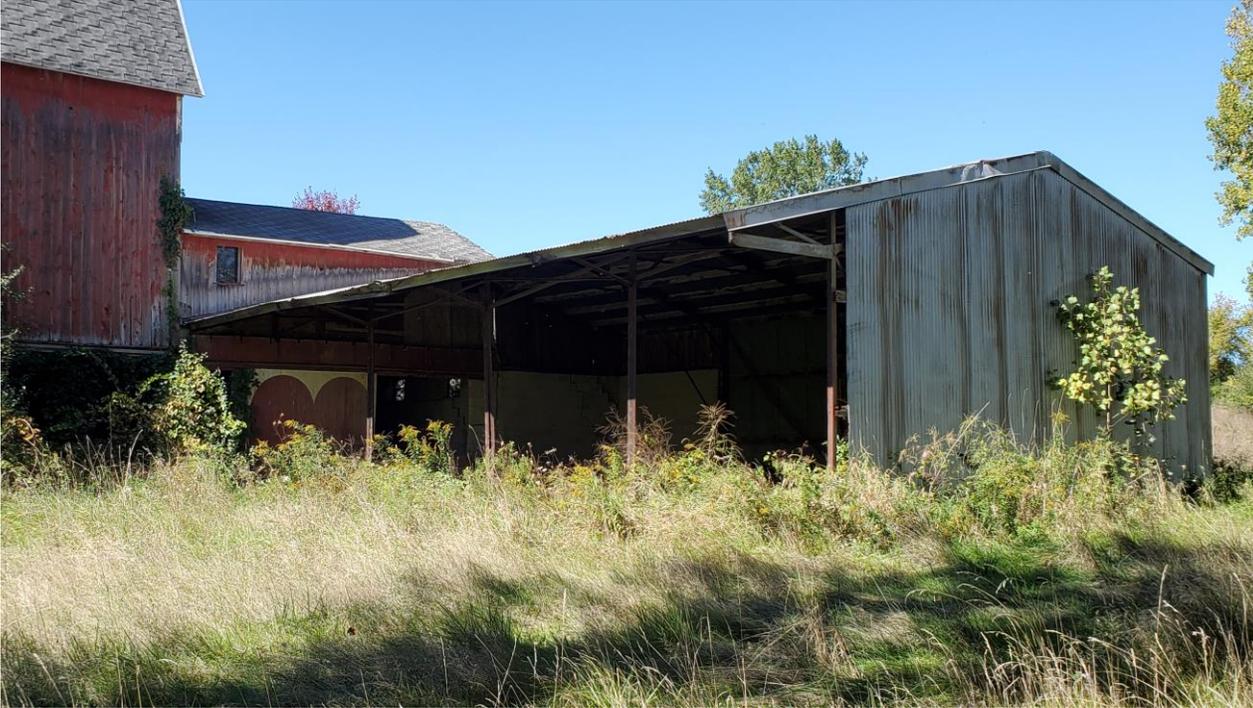
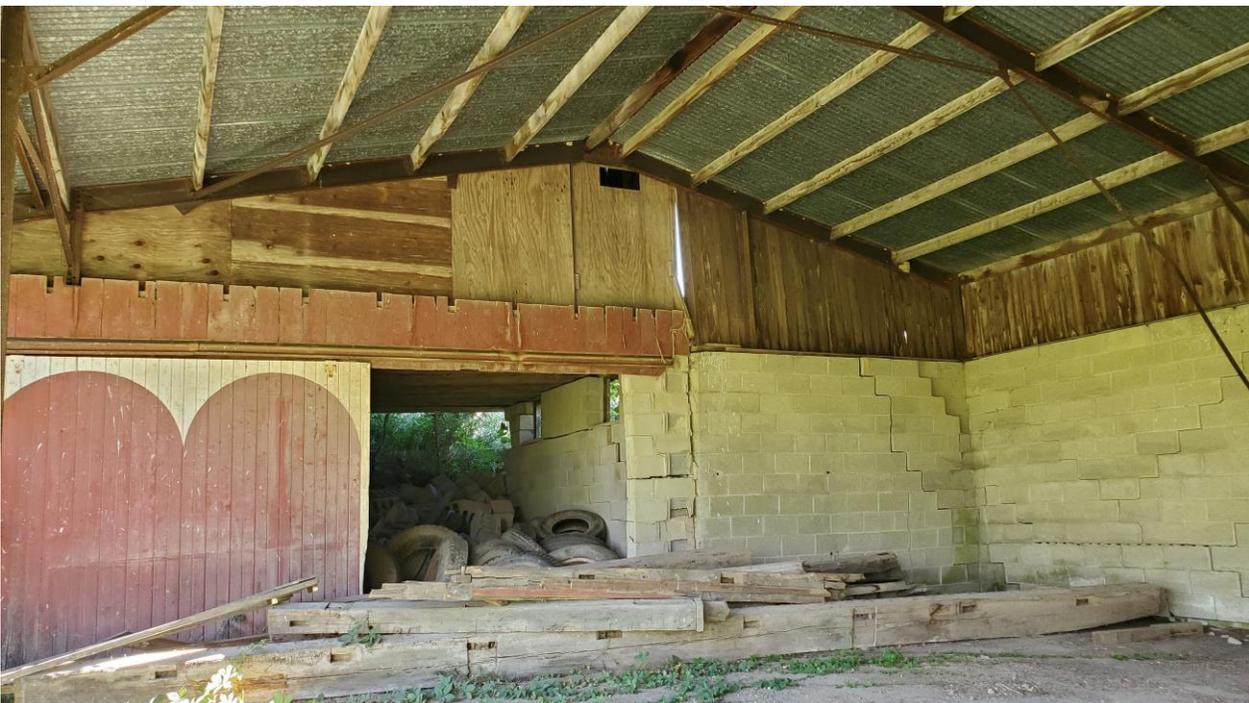
Loafing Shed

Facing northwest from the east side of the barn complex; second view facing west to the barn interior.

This side-gabled three-sided shed is an enclosure for livestock shelter. It is made of a mixture of corrugated metal and vertical wood siding. It is directly attached to the sheds on the north side of the barn. On the north and northwest sides, part of the structure is supported by an unstable and crumbling concrete block wall.

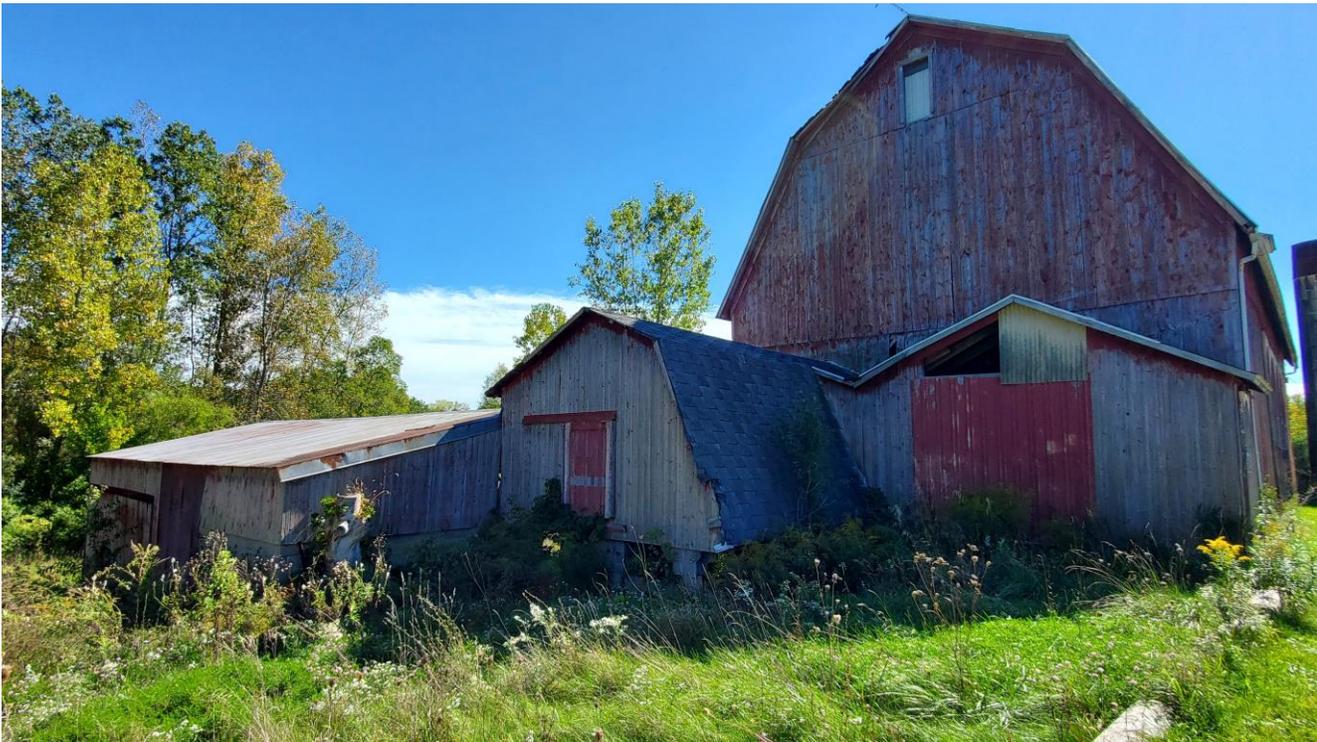
North Sheds

Facing southeast from the Livestock Gates.

One small and one medium-sized shed are appended to the north elevation of the Gambrel Barn. Both have concrete block foundations which are crumbling and a mixture of materials covering their roofs. The smaller shed is gable-fronted and enclosed with a mixture of vertical wood siding and corrugated metal. The medium-sized shed has a haphazard roofline approximating a gambrel. It is sided in vertical wood. Neither shed are stable enough for close examination.

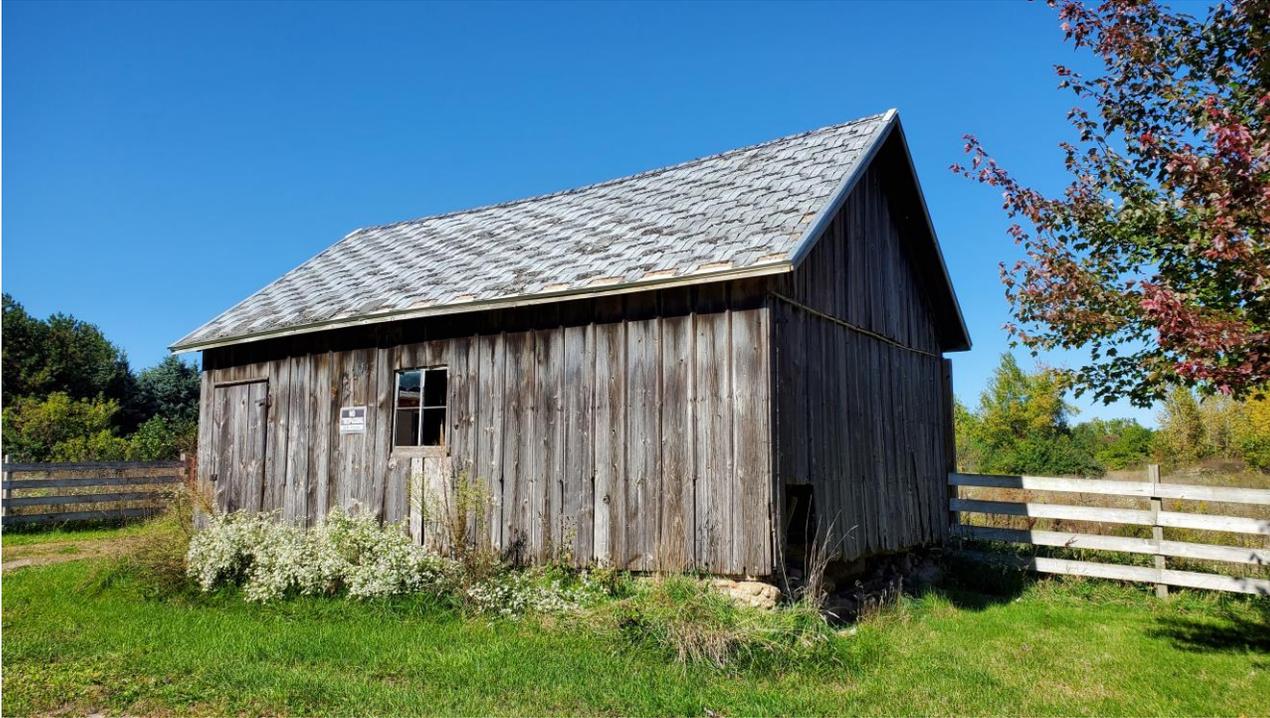
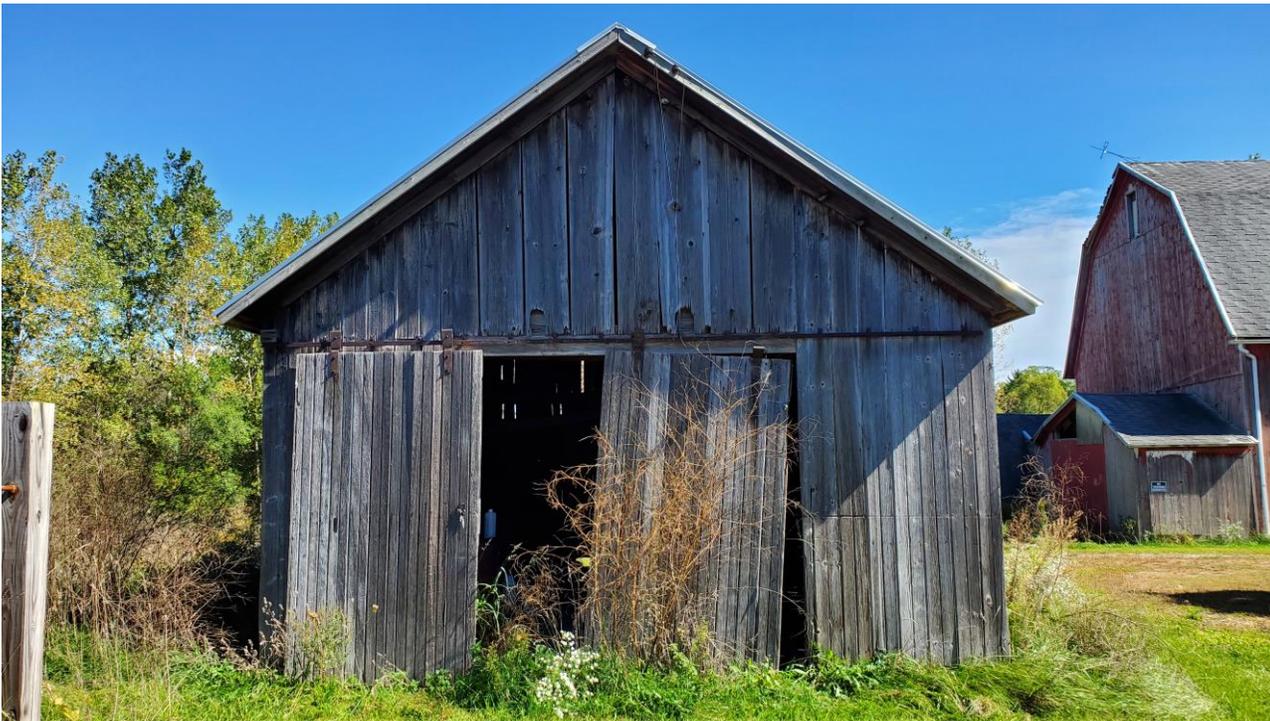
Sheep Barn

Facing northwest from the barn yard; second view facing east from the farm lane.

Gable-front livestock barn with field stone foundation, vertical board and batten wood siding, asphalt shingle roofing, and entries on the south and west elevations. There is a square, wooden-framed, four-pane window on the south elevation.

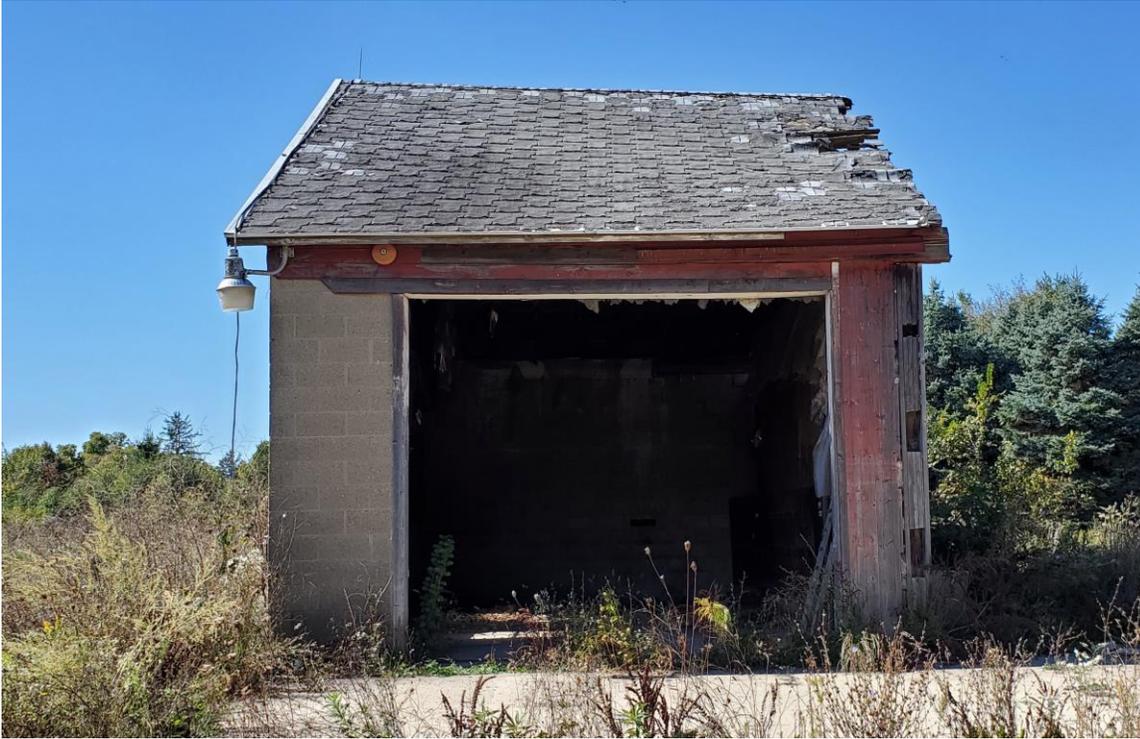
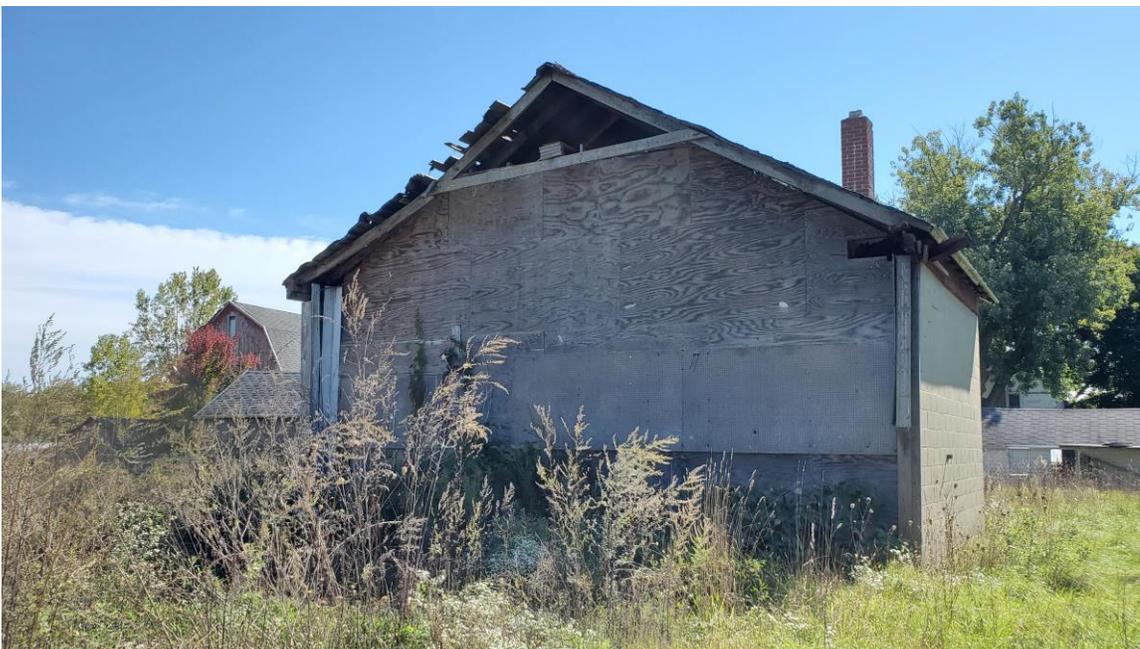
Machine Shed

Primary elevation, facing west; second view facing southeast.

This side-gabled shed is composed of concrete block on three sides and a makeshift plywood enclosure on the north side. Its asphalt shingles are failing, with segments shorn off. This structure appears to date to the early to mid-20th century. At one time, it was much wider, with ruins of a former additional bay still visible. This shed is quite tall, of a height which would accommodate heavy machinery. It is not structurally stable.

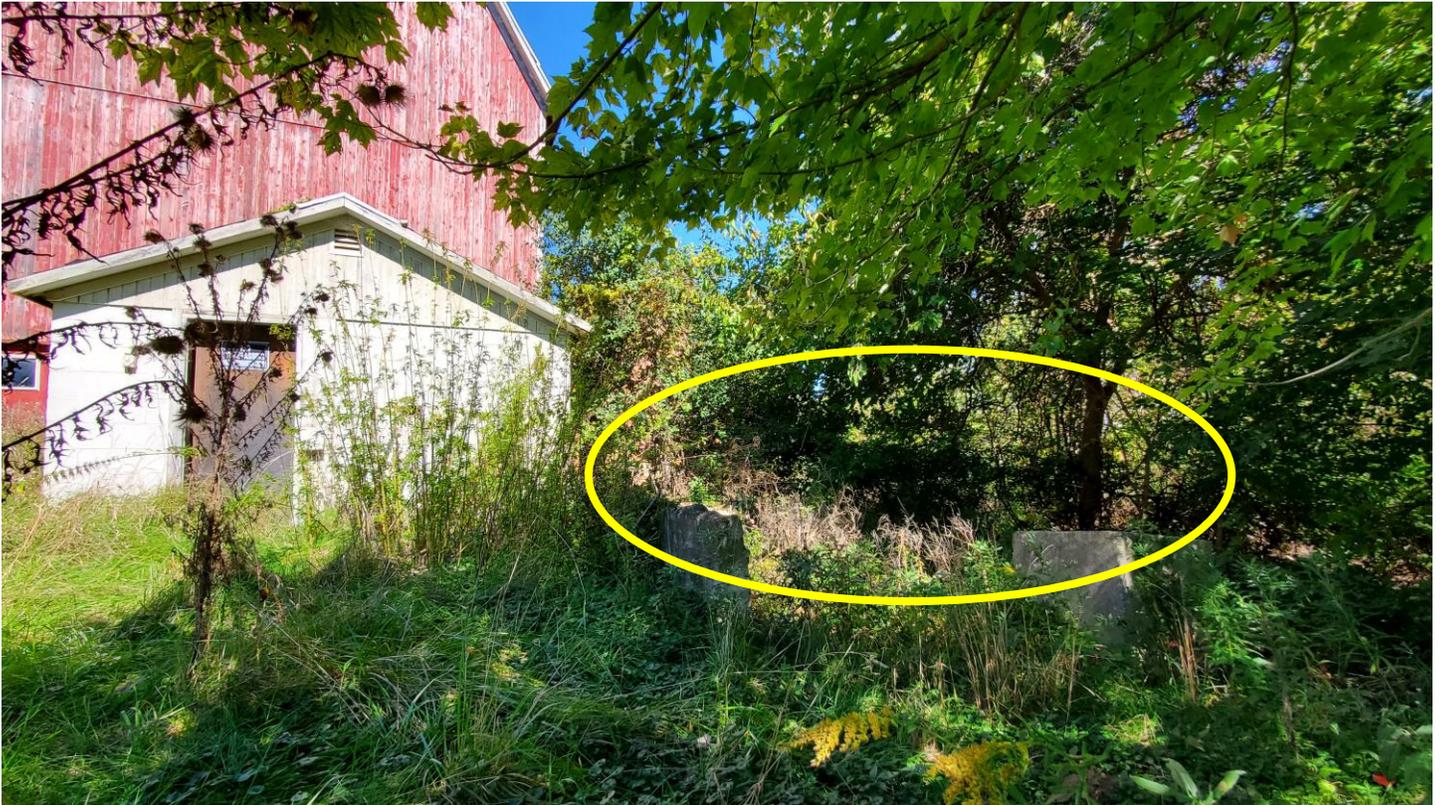
Feed Bunk Ruins, south side of the barn, facing northeast.

These poured concrete foundation pieces appear to have been part of a feed bunk.

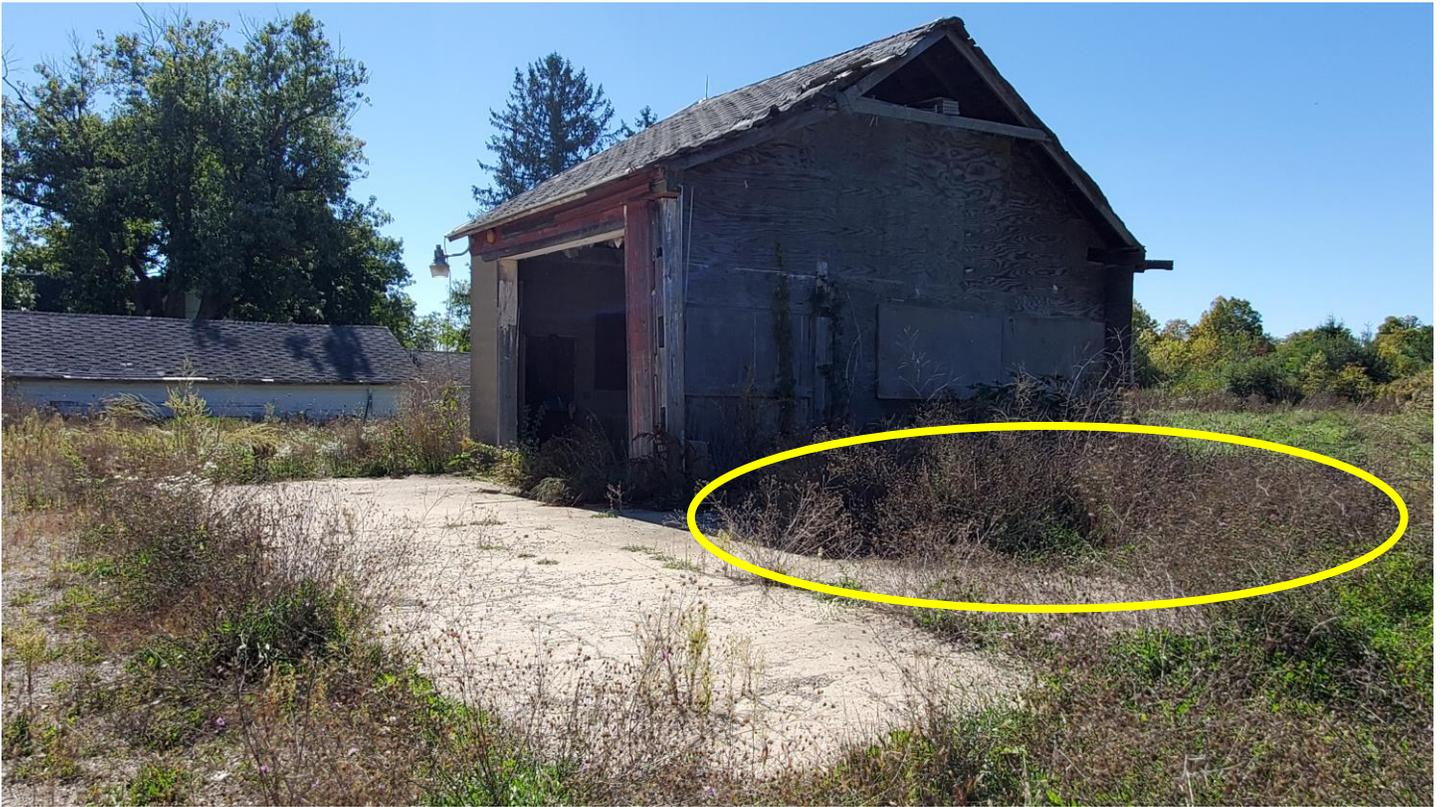
Concrete Pad and Shed Remnants

North end of the property, facing southwest.

The machine shed was at one time wider; a footprint of the former north bay remains visible.

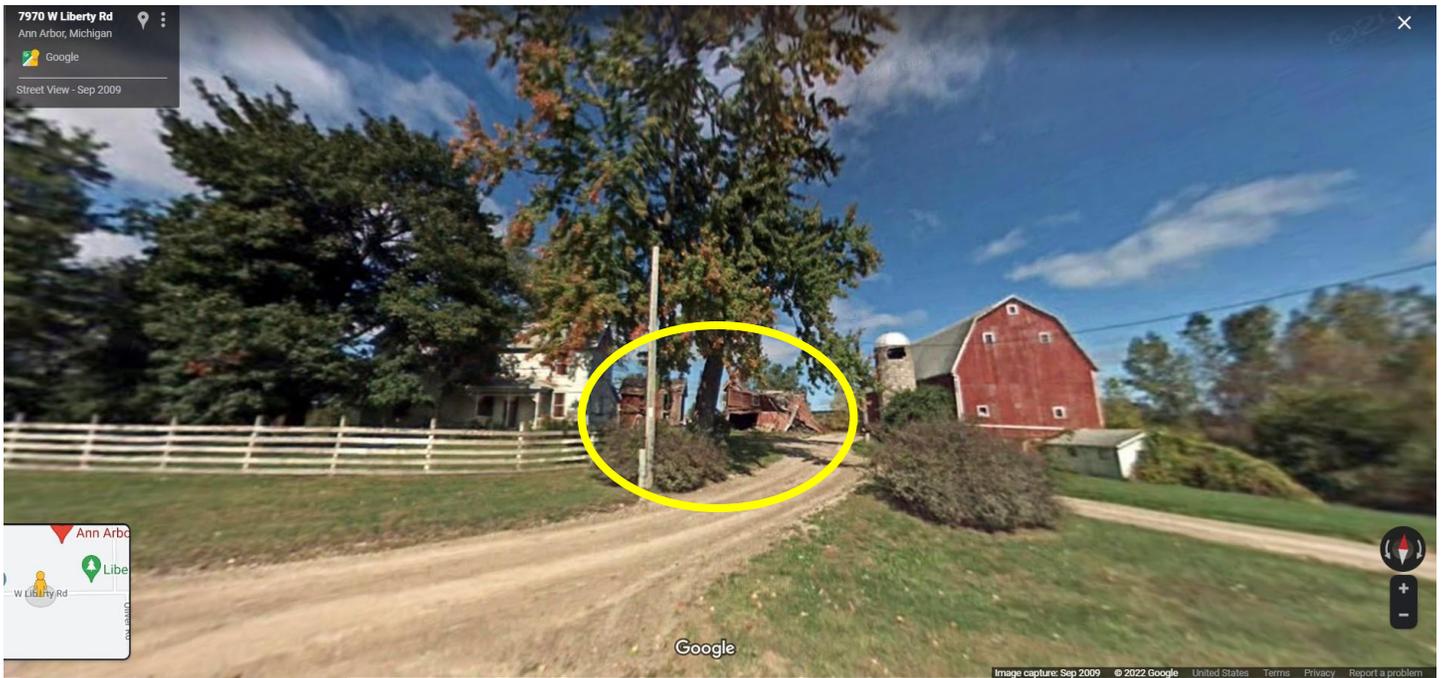
Carriage Barn and Woodshed

2009 Google Street View facing north from roadway.

It appears that a side-gabled woodshed and a side-gabled carriage house were in active deterioration at the time of this photograph.
