Wild-Frey Farm Historic Resources Survey Report

7970 Liberty Road
Scio Township
Washtenaw County, Michigan

Washtenaw County Office of Community & Economic Development
Final Report
December 1, 2022

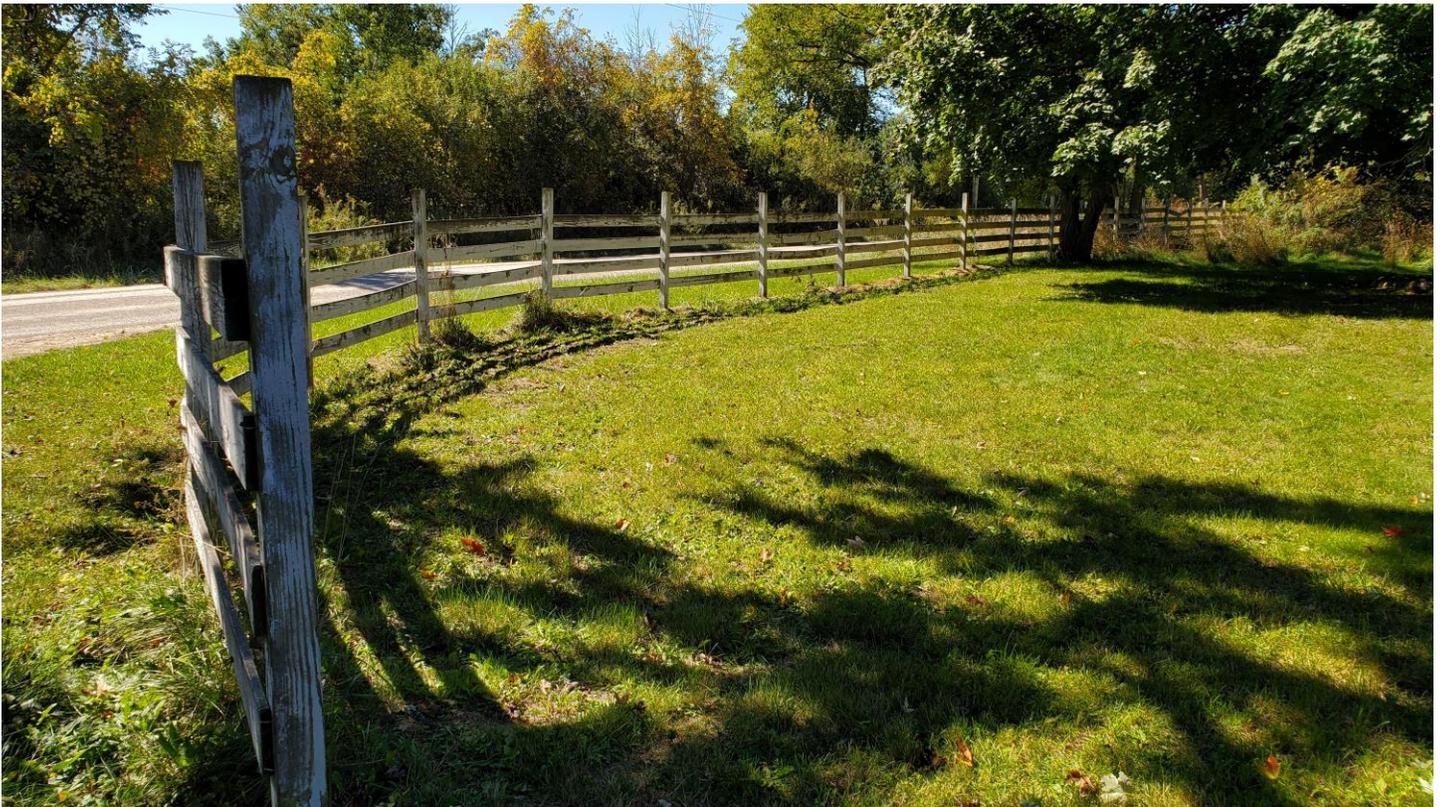
Post and Rail Fence

Door yard (front yard) facing southwest.

A white painted post and rail fence serves to demarcate the general boundaries of the door yard surrounding the south and east sides of the house. This wooden fence is made of vertical posts approximately four feet high, traversed by four rows of horizontal boards approximately six feet wide.

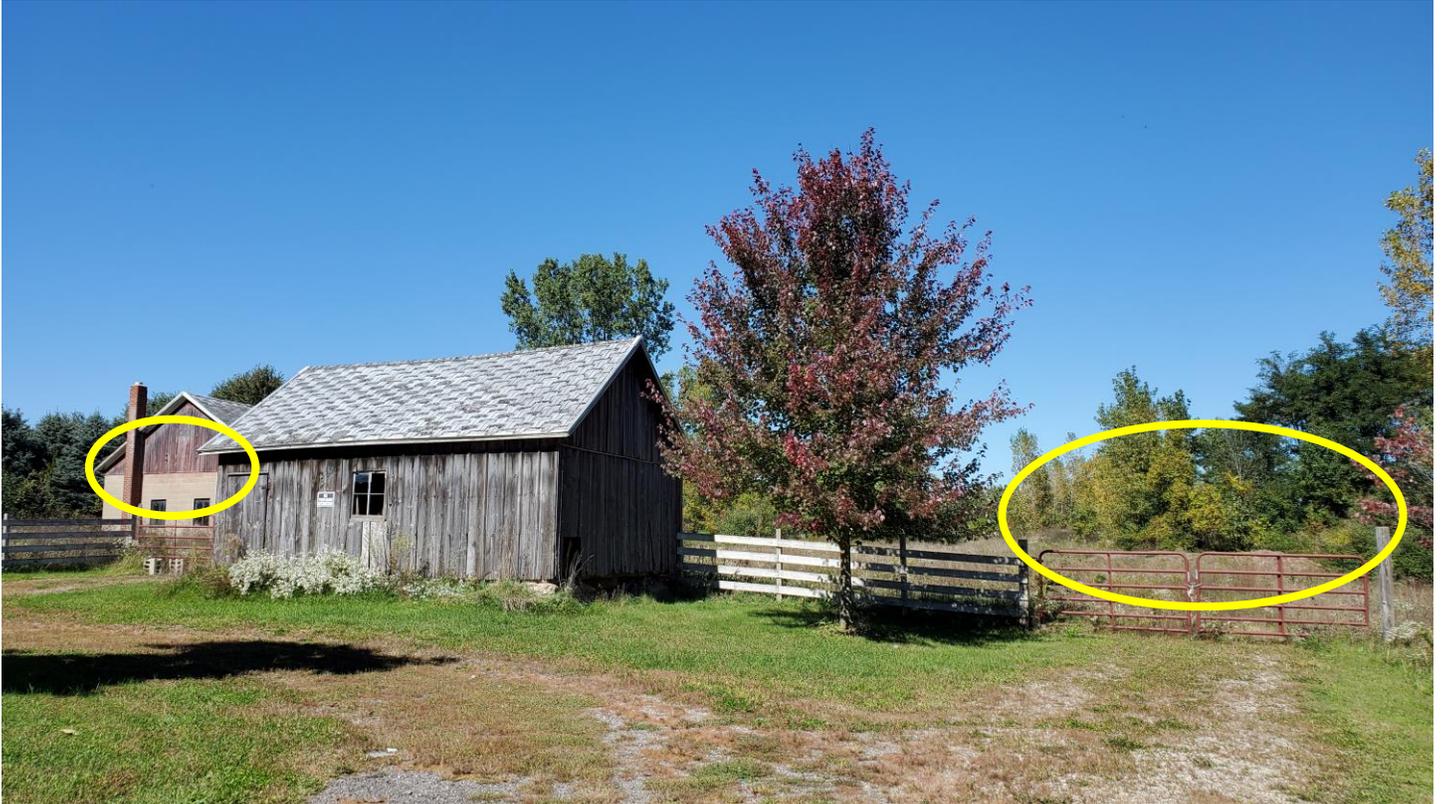
Double Livestock Gates

Barn yard facing north.

These metal tube gate set separate the barn yard from the north end of the property. They provide access to the farm lane which extends from the barn yard to an open space area. This area is less defined than those closer to the main outbuilding cluster, as it has been altered by non-agricultural uses in the late 20th century.

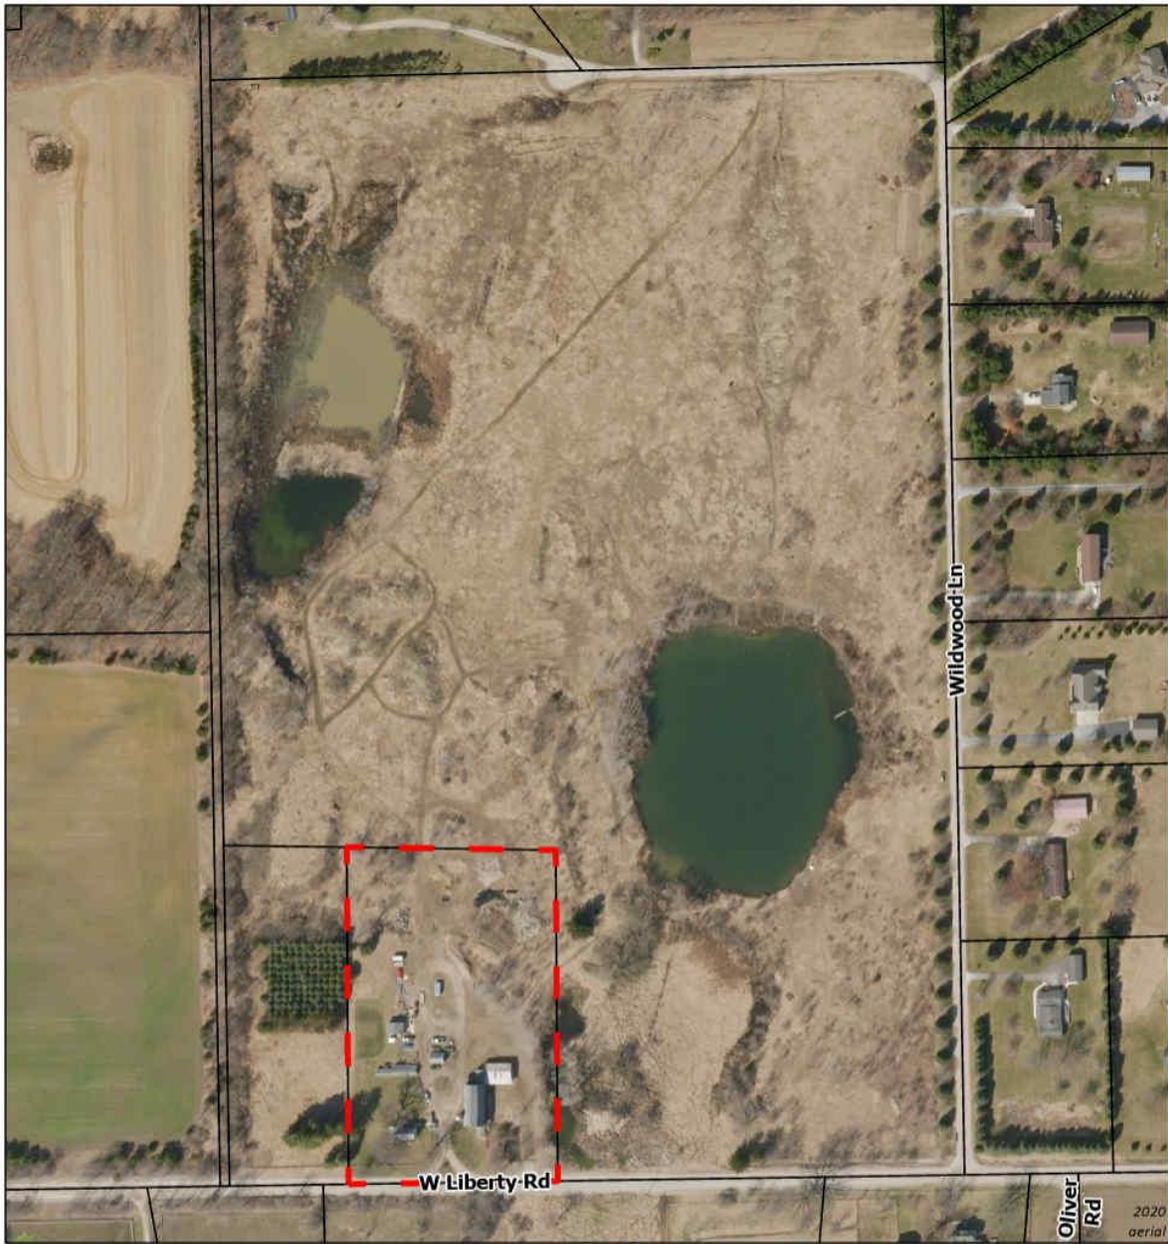
Appendix A: Base Map of Potential Historic District, 2022

The potential local historic district is comprised of the entire 5-acre parcel at 7970 W. Liberty Road, known as the Wild-Frey Farm. Potential contributing resources include a farmhouse, toolshed, chicken coop, garage, barn complex with milk house, two shed attachments, silo, and loafing shed; sheep barn, and machine shed. Notable landscape elements include extant fencing around the house and livestock gates near the barn yard.
